Joint Investigation by Senoko Power and PETRONAS Gas Berhad into the Gas Supply Disruption at Senoko Power Station on 21 December 2006

Summary of Incident

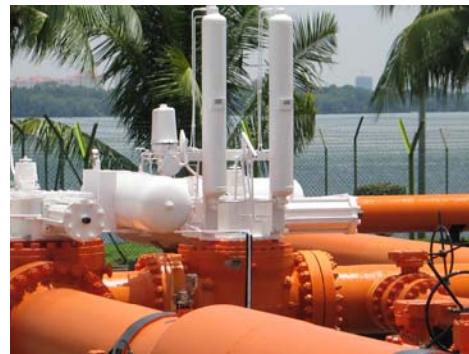
Valve ML401

9. The joint investigation included site tests and simulations conducted by the original equipment manufacturer. The investigation concluded that the cause of the gas supply disruption on 21 December 2006 was the unexpected automatic closure of ML401 that was activated by the self-closing mechanism.
10. The investigation reviewed all possible causes of the self-closing mechanism. The most important facet of the investigation was to eliminate any recurrence of this incident through the elimination of the only cause for the unexpected closure, the self-closing mechanism.

- the Senoko Pig Receiving Facility. A self-closing mechanism had been activated, causing the automatic closure of ML401.
16. The investigation reviewed all the possible causes of the self-closing mechanism. Consequently, Senoko Power and PETRONAS Gas Berhad, the pipeline operator for PETRONAS, concentrated on the modification of the self-closing mechanism to remove this vulnerability. This was identified to be the root cause. Action has already been taken to ensure that this type of incident cannot recur.
 17. Both Senoko Power and PETRONAS Gas Berhad are confident that the measures they have taken will be sufficient to prevent a repetition of the incident.

12. Senoko Power and PGB have proceeded, since the incident to strengthen the robustness of the gas supply system.
13. Following consultation with the original equipment manufacturer, the valve actuation system for ML401 will be modified and this new system has been ordered to replace the existing equipment.
14. Senoko Power has also taken the opportunity in the interest of continual improvement to review the work procedure and control arrangements for work at the Senoko Pig Receiving Facility.
